Evaluation of Traffic and Safety Conditions

West Todd Street at Joyce Road II

February 2017

Revised May 2017

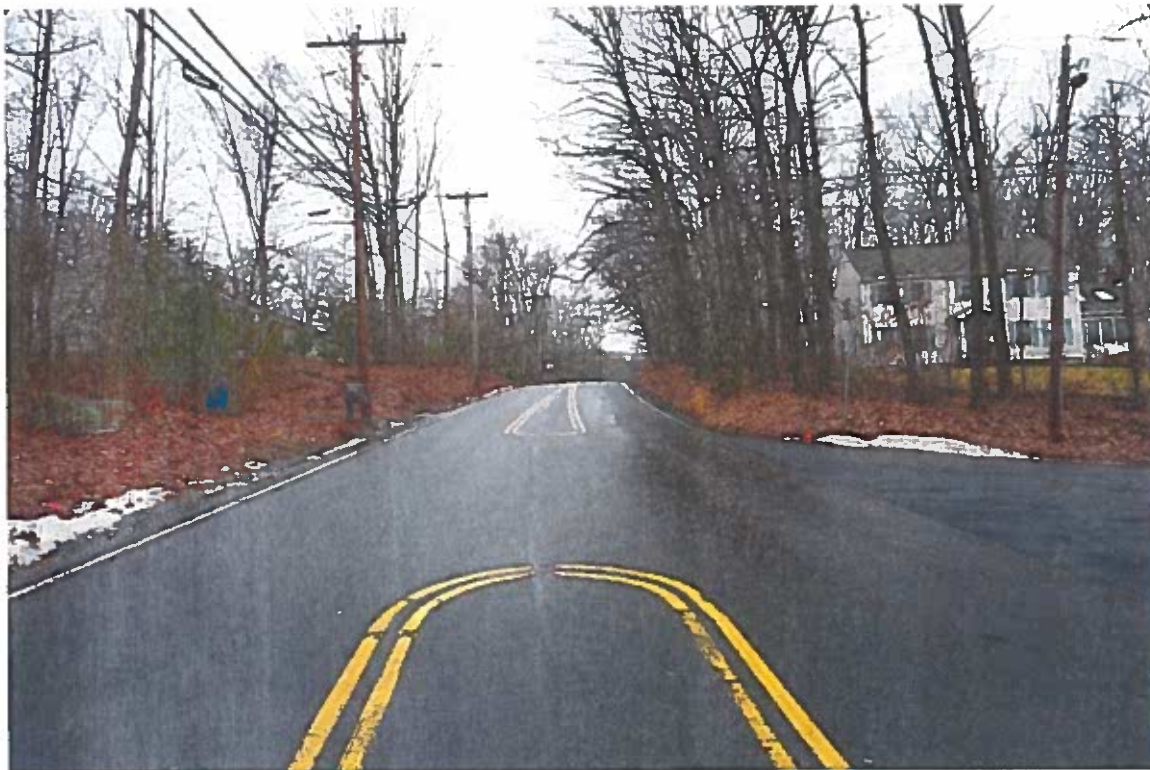
Figure 1- Looking West on West Todd Street at Joyce Road II

West Todd Road is a two-lane undivided facility classified as Urban Local Road. The posted speed limit is 25 MPH. The curb-to-curb width of the street is approximately 30 feet. Travel lanes are 11 feet wide and delineated by edge markings (2-4 inch shoulder width). Bituminous concrete curbing installed on both sides of West Todd Street. West Todd eastbound approach to the intersection of Joyce Road II has approximately 10% down grade. West Todd Road is operating under a free flow condition. There are no sidewalks or bike facilities present along West Todd Street.

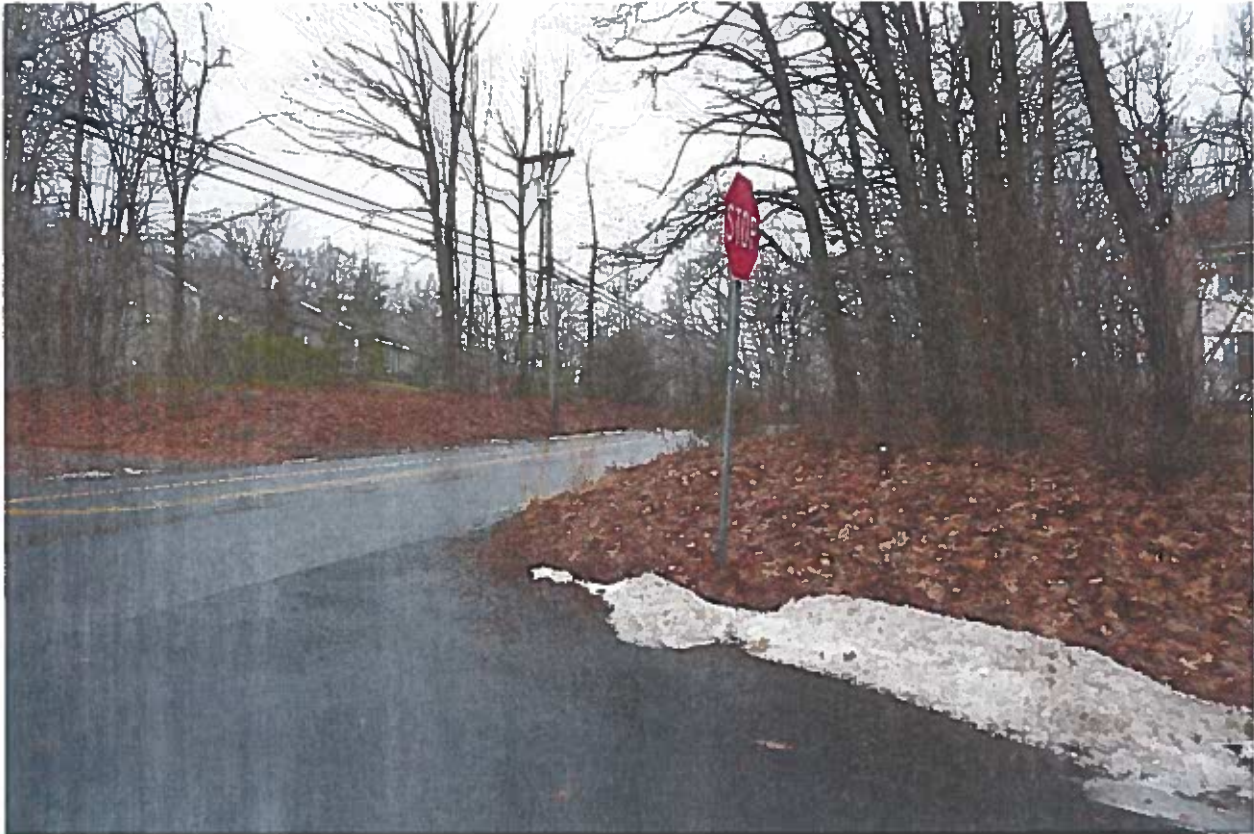
Figure 2 - Joyce Road II Looking West onto West Todd Street

Joyce Road II is a two way undivided roadway and classified as Local Road. Joyce Road is 30 feet wide curb-to-curb. Joyce Road II is a dead-end street. There are no sidewalks along Joyce Road II.

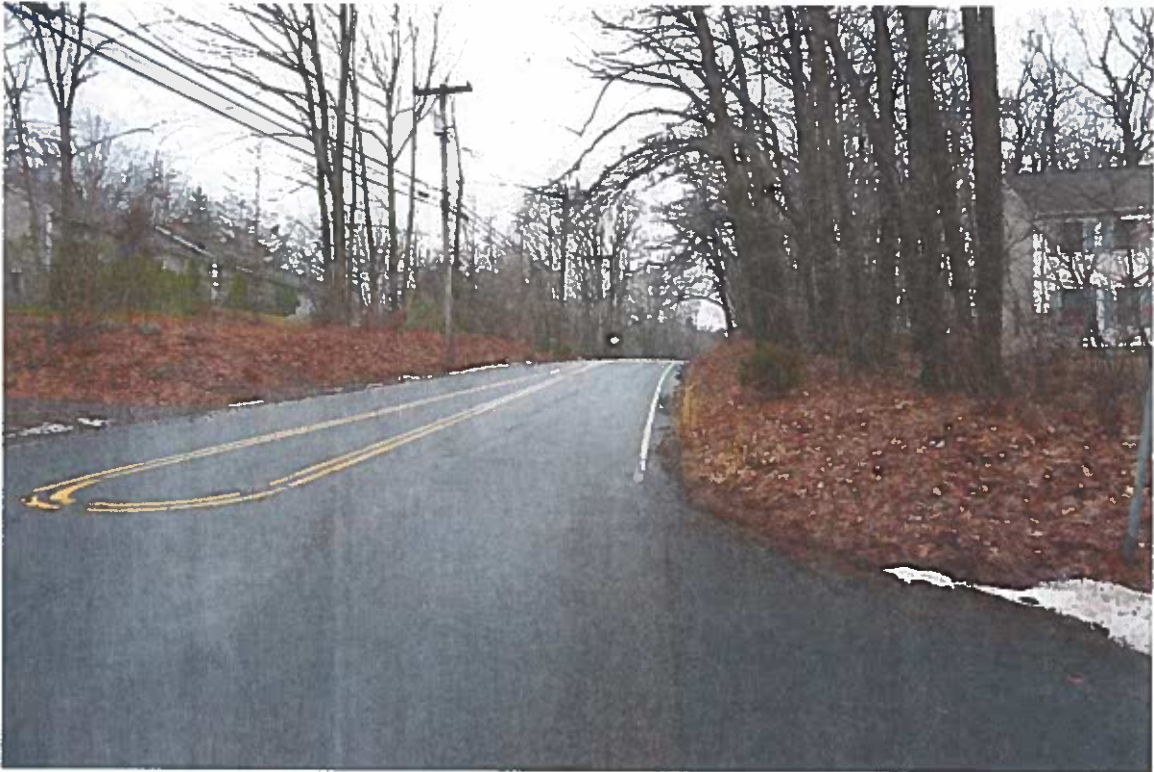
Figure 3- Intersection Sight Distance to the Right (West Todd Street Eastbound)

The current ISD to the left (westbound approach) is 85 feet, and to the right is 200 feet. Figure 3 thru 5 exhibits the existing ISD.

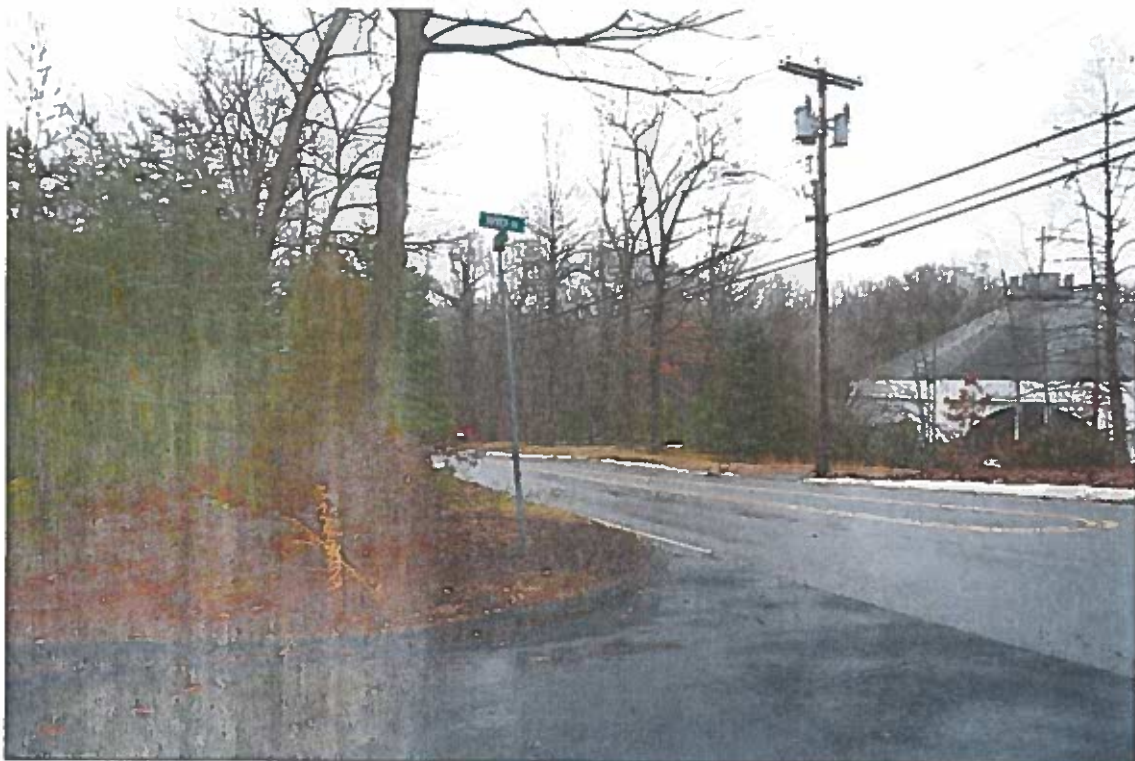
Figure 4 - Intersection Sight Distance to the Left (West Todd Street Westbound)

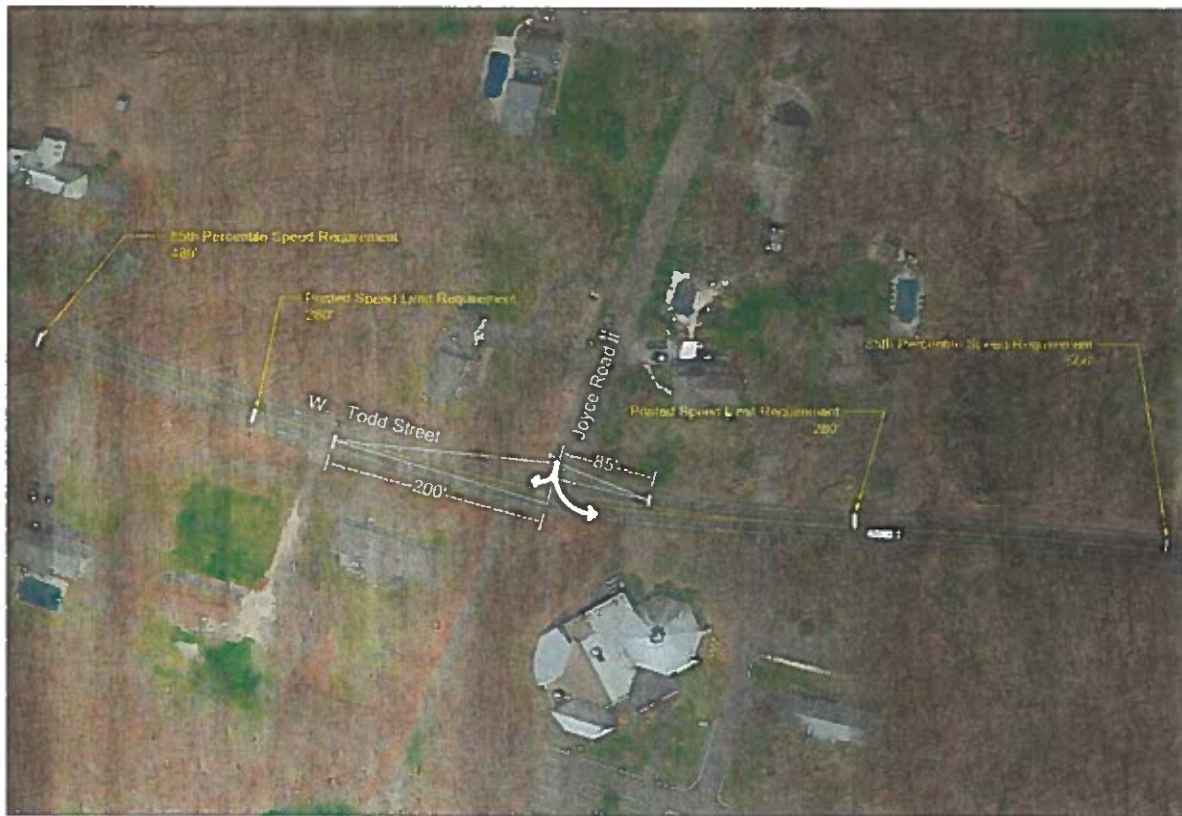
Figure 5- Existing and Required Intersection Sight Distance

Based on the posted speed of 25 mph along West Todd Street, the CTDOT Highway Design Manual indicates that passenger cars from minor road require 280' of sight line for entering onto West Todd Street. Based on the recorded 85th percentile speeds of vehicles on West Todd Street (44 mph eastbound and 48 mph westbound) using linear interpolation, passenger cars require a clear sight line of 489 feet to the east and 566 feet west of intersection.

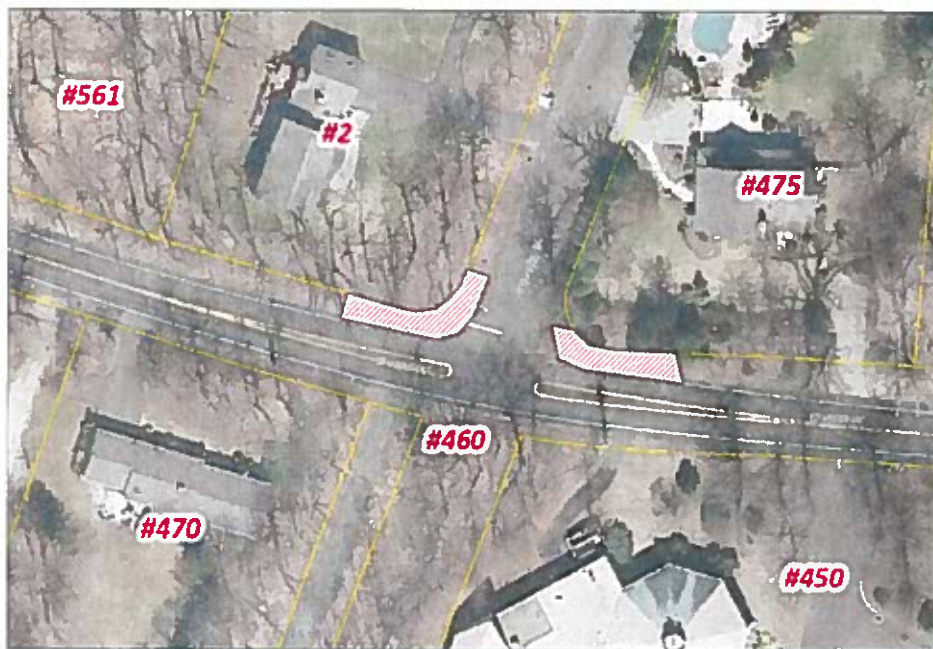
Figure 6- Limits of Clearing Vegetation

The driver sight line exiting from the Joyce Road II onto West Todd Street is very important. It is recommended to cut back and clear shrubbery, and low lying seedlings/trees within City's Right-Of-Way. The figure below illustrates the areas of clearing within the ROW.

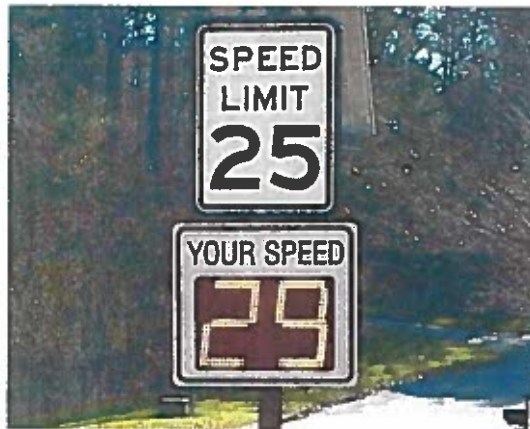
Figure 7- Intersection Sign and Radar Speed Detector

1. It is recommended to enforce the speed limit at random intervals.
2. It is recommended to install Intersection Ahead (W2-2 (L and R)) signs with supplementary distance signs on West Todd Street – approximately “450 FT” and “400 FT” along eastbound and westbound approaches, respectively. The alternating flashers powered by solar panel are optional.
3. It is recommended to install solar powered Radar Speed Detectors along West Todd Street approximately at 370’ and 275’ for the eastbound and westbound approaches, respectively. The proposed locations of signs and Radar Speed Detectors are shown on Figure 9.

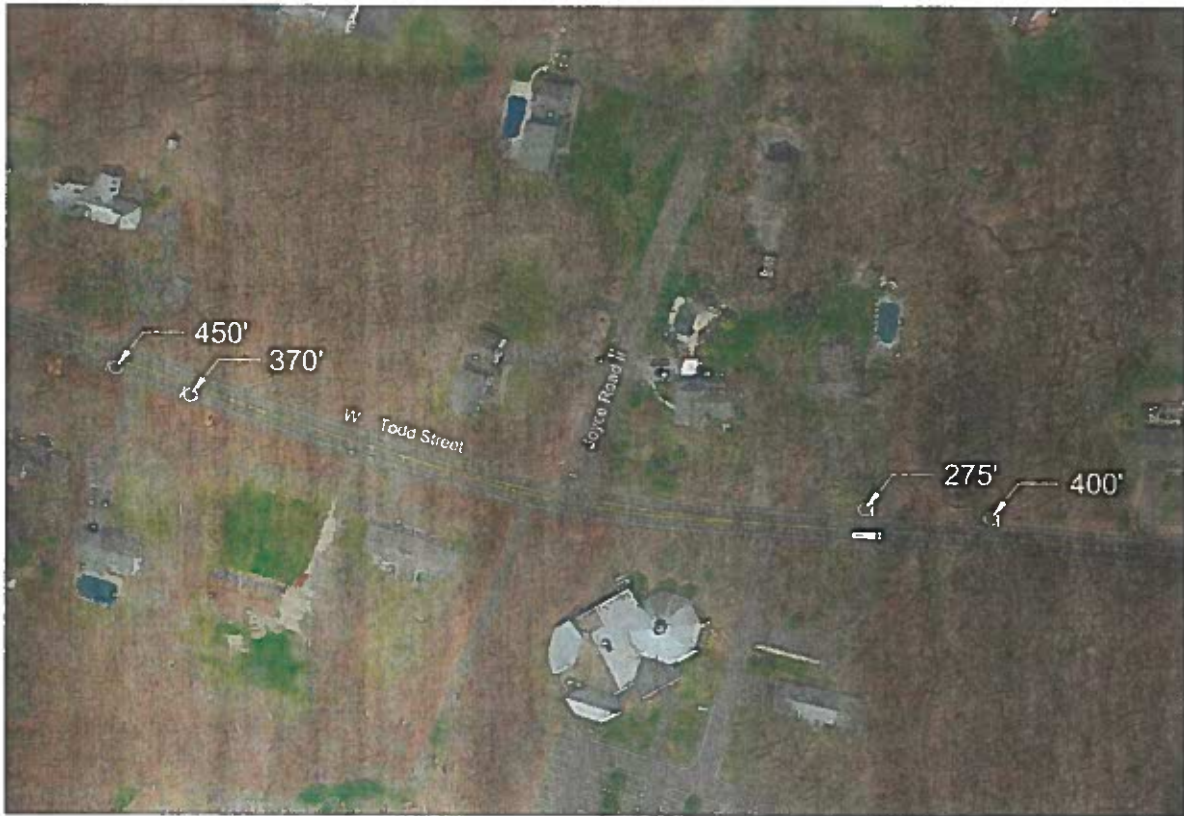
Figure 8- Proposed Warning Sign and Speed Radar Detector Location

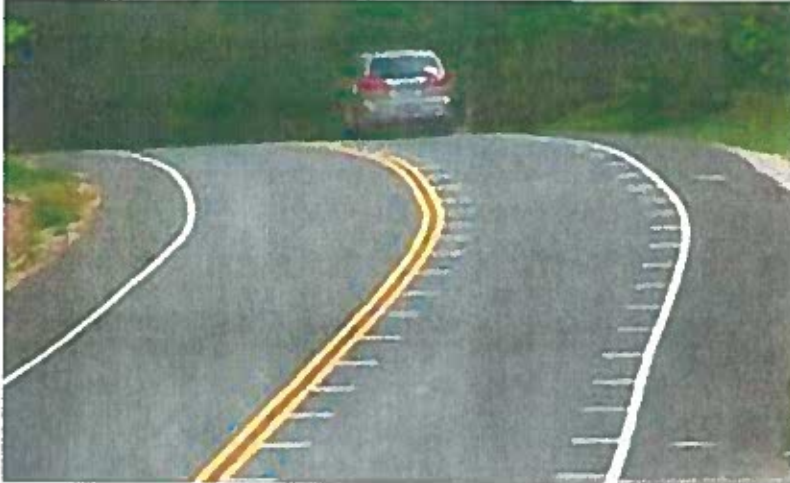
Figure 9- Transverse Pavement Marking

In order to provide visual queue to the drivers to reduce speed approaching the intersection, it is recommended to install transverse pavement markings along West Todd Street.
